# Environmental Analysis of the Queixada Stream Watershed In Jataí-Goiás (Brazil)

**ABSTRACT:** *The present work consists of a scientific investigation that addresses the study of the Queixada Stream watershed, located in the municipality of Jataí, southwest of the state of Goiás, Brazil. The main objective is to analyze the water quality and environmental vulnerability of this watershed. Land use and occupation are essential elements for evaluating and understanding the physical characteristics of the environment. Urban expansion in Jataí has negatively impacted areas of natural vegetation and water sources, and the study area of the Queixada Stream watershed is no exception. This expansion is associated with population growth, resulting in increased demand and expectations for socioeconomic development, which in turn implies greater consumption of natural resources. The overall objective of this study is to conduct a comprehensive environmental analysis of the Queixada Stream watershed in the municipality of Jataí, Goiás. In addition, the water and soil quality will be evaluated, using resolutions 357/2005 and 420/2009 from the National Council for the Environment (CONAMA) as p

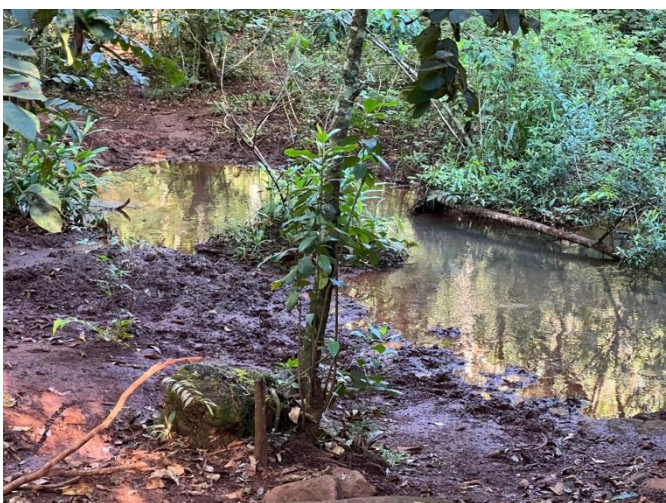
At the first point, located near the source of the Queixada Stream, a remarkable predominance of pastures and livestock activities was evident. The analyzed area showed clear signs of cattle farming, with traces and marks left by the animals.

**Figure 3 - Animal tracks at point 1**

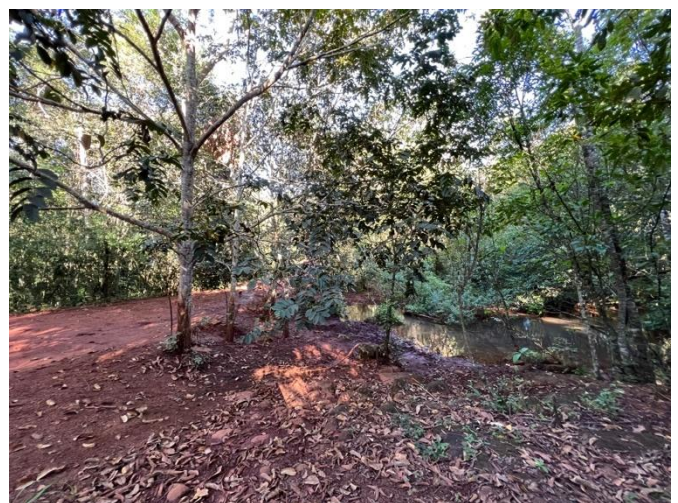
However, it is also possible to observe stretches of exposed soil, where natural vegetation has been removed, leaving the soil unprotected and vulnerable to compaction. This removal of vegetation may result from intensive agricultural activity or other activities involving the exploitation of natural resources.

**Figure 4 - Exposed soil at point 1**

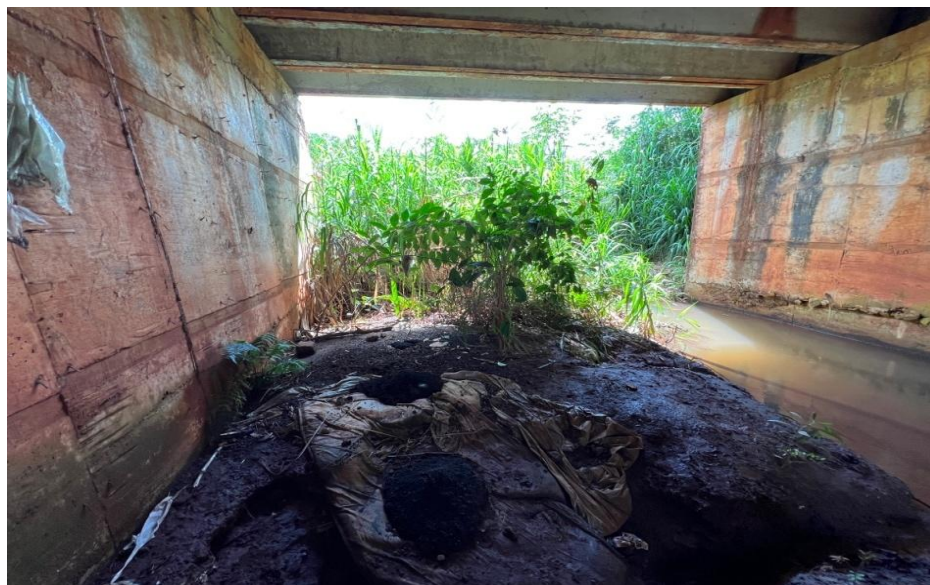
At the second point, located under a bridge in the urban perimeter of the city of Jataí, the presence of plastic debris was observed. These debris were found both on the stream's banks and in its bed. These plastic residues are the result of human activity, probably improperly discarded. Additionally, it is possible that some of these debris have been carried by rainwater runoff, accumulating at the site. The presence of these plastic debris highlights the need for environmental awareness and the adoption of measures to minimize stream pollution.

**Figure 6** - Trash on the stream banks under the bridge.

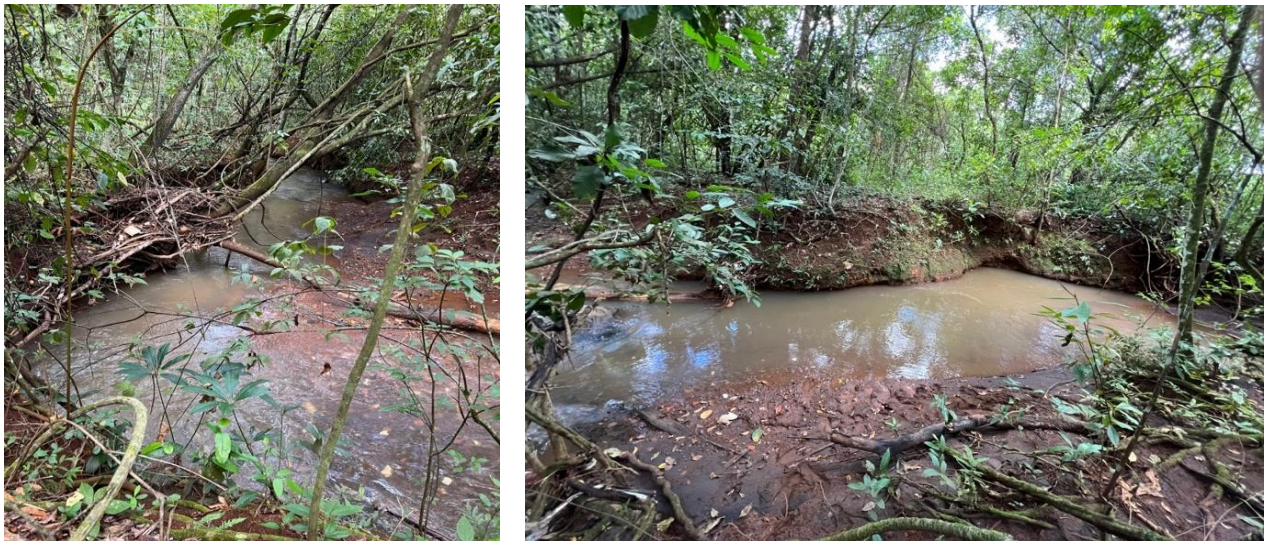
At the third point, located near the mouth of the stream, different characteristics were observed. Firstly, the presence of erosions was noted, indicating processes of soil wear and removal in the area.

Additionally, sandbanks were identified, possibly resulting from siltation caused by the transportation of sediments along the stream. Furthermore, construction debris was found, suggesting human activities in the region that may have contributed to environmental degradation. Finally, a large amount of debris brought by the rain was noticed, which may include solid waste and various materials.

Figure 8 - Debris anchored to tree roots Figure 9 - Streambedded at point 3.

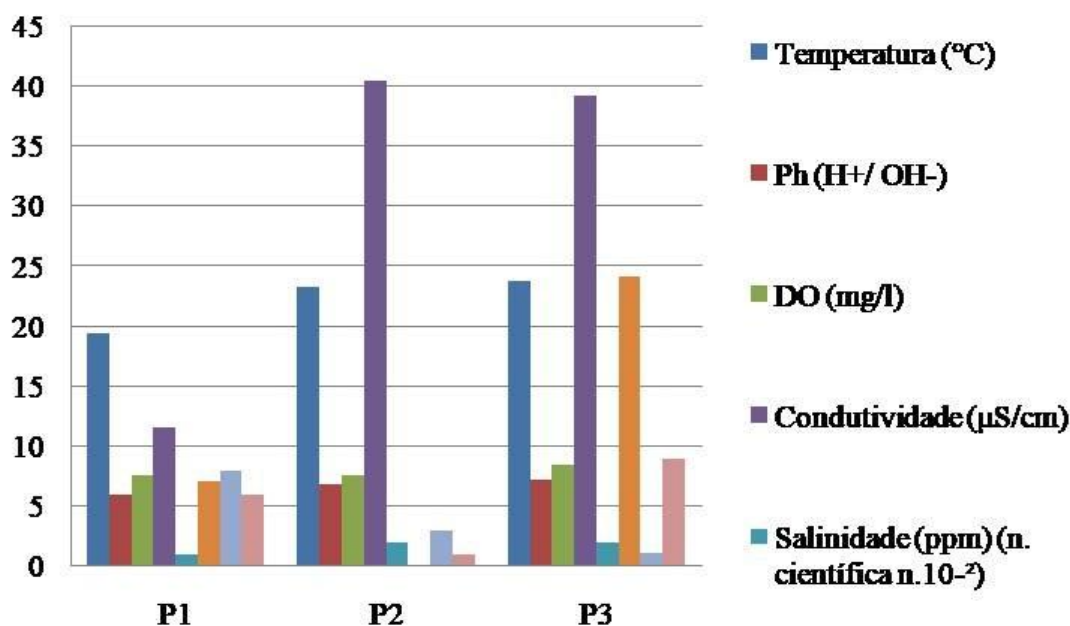
**Graph 1** - Results obtained with a probe to measure water temperature, pH, DO (Dissolved Oxygen), electrical conductivity, and salinity.

According to graph 1, the temperature varied between 22°C to 24.3°C, with a range of 2.3 degrees Celsius, which is due to the collection time, as point 3 showed the highest temperature. Water temperature is a parameter of great importance for the aquatic community since it influences most of the physical, chemical, and biological processes (ROCHA, CABRAL; NOGUEIRA; BARCELOS, 2015).

The observed pH values (graph 1) varied from 6.52 to 7.11, with the most acidic pH 6.52 found at point 1 and the most neutral pH 7.11 at point 3. Lower pH values can increase water corrosivity, leading to the presence of substances such as iron and manganese, which give it an unpleasant taste. Higher pH values can also attack metals (LIRA, 2014).

According to the analyses, DO presented values ranging from 7.41 mg/L to 8.9 mg/L. According to CONAMA Resolution No. 357/05, the samples should not contain values below 6 mg/L for Class 1; 5 mg/L for Class 2; 4 mg/L for Class 3; 2 mg/L for Class 4.

The Electrical Conductivity (EC) parameter is defined by its capacity to conduct electric current, associated with the concentration of dissolved ions (salinity content), which are 87 electrically charged particles (ESTEVEZ, 1998; PAULA, 2010). According to graph 1, EC ranged from 12.4  $\mu\text{S}/\text{cm}$  to 42.4  $\mu\text{S}/\text{cm}$ .

Analyzing graph 1, NaCl (salinity) showed the lowest values at point 1. It was observed that NaCl values ranged from 0.01 to the minimum and 0.03 mg/L to the maximum.

The results highlighted that, regarding the evaluated physical-chemical parameters, dissolved oxygen and electrical conductivity values did not comply with those recommended by CONAMA. However, most of the physical and chemical parameters analyzed are in accordance with the standards set for human consumption. Nevertheless, anomalous values were detected at some points.
